**THE STREAMBANK EROSION CONTROL  
EVALUATION AND DEMONSTRATION ACT OF 1974  
SECTION 32, PUBLIC LAW 93-251**

## Appendix F - Yazoo River Basin Demonstration Projects

# FINAL REPORT TO CONGRESS

U.S. ARMY CORPS OF ENGINEERS  
December 1981

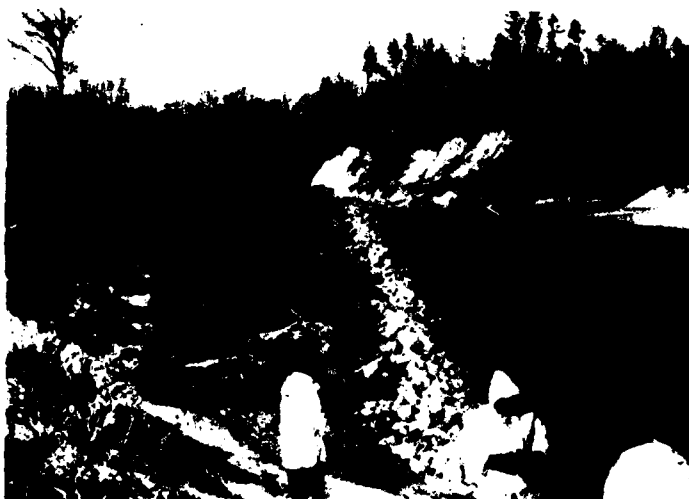
After Construction  
Jan 1979

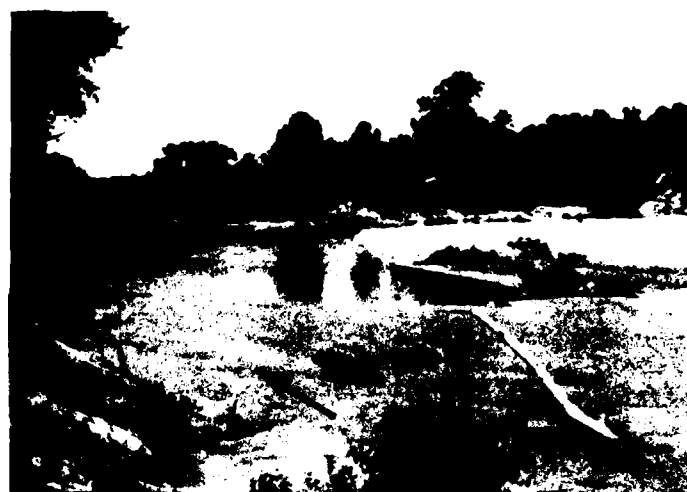
After Damage  
Looking Downstream  
Along Old Dike Alignment  
July 1980

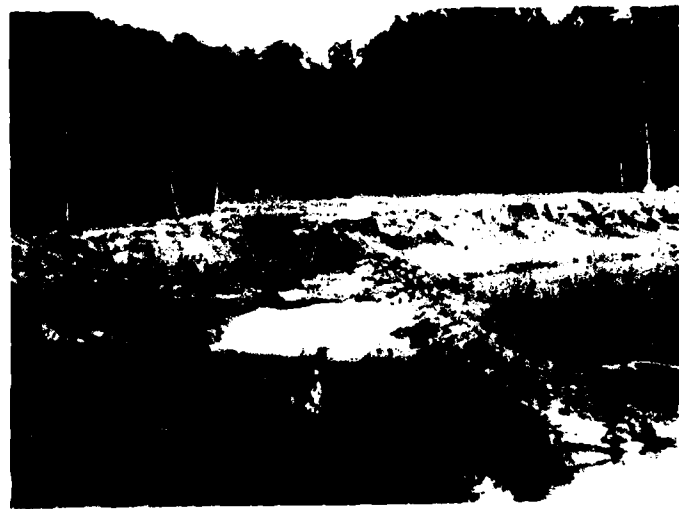
After Damage  
May 1978

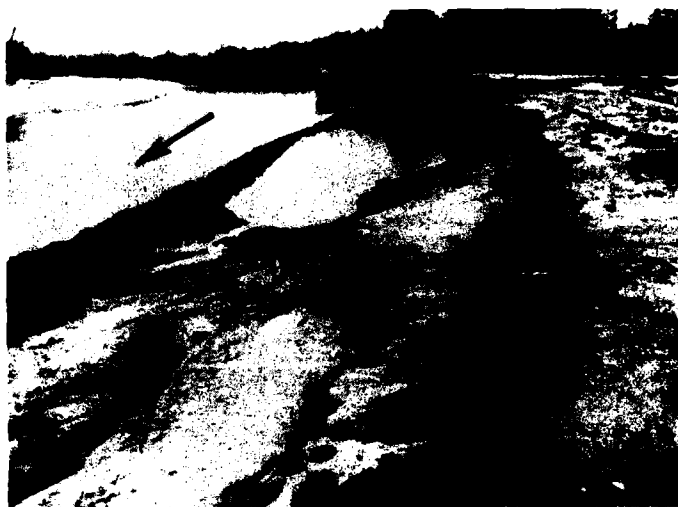
After Damage in Late  
Nov 1977
